**Service  
Manual**

# hp StorageWorks Edge Switch 2/12

**Product Version:** FW v06.xx/HAFM SW v08.02.00

**Part Number:** AA-RURDB-TE

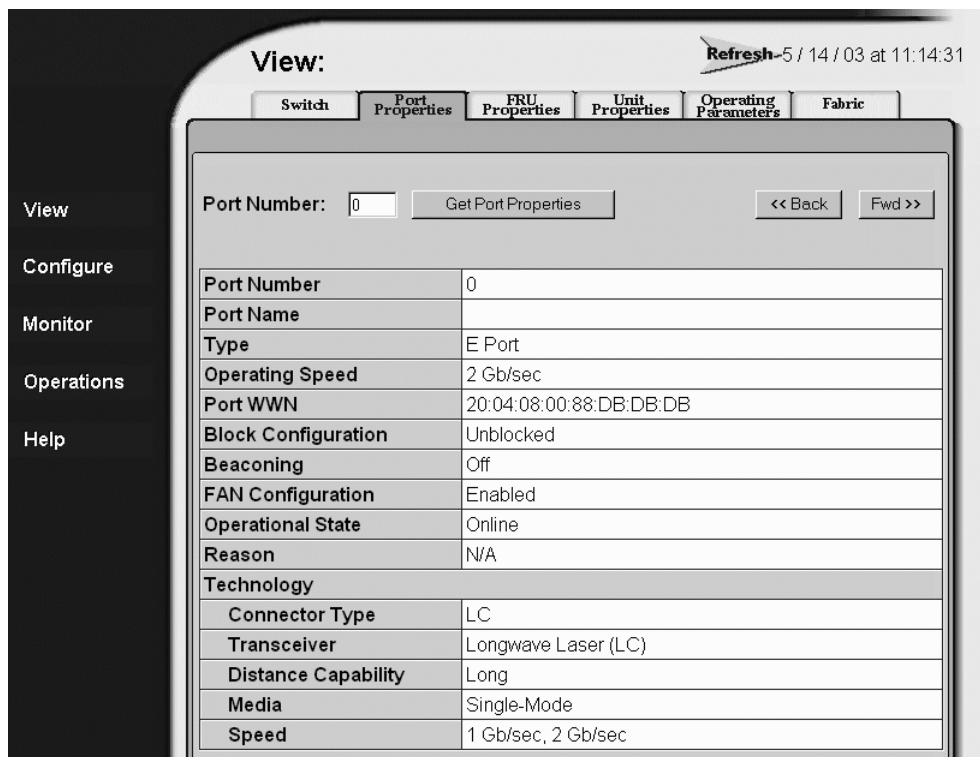
**Figure 19: View panel (Port Properties page)**

When the EWS interface opens, the **View** panel appears as the default panel. At the **View** panel, click the **Port Properties** tab. The **View** panel displays with the **Port Properties** page selected (Figure 19).

The **Port Properties** page displays information for one port. Values update only when the page opens for a selected port or the user selects **Get Port Properties**. The page defaults to port **0**. Increment or decrement the port number displayed (**0** through **11** inclusive) by clicking **Fwd>>** or **<<Back**. The page provides the following information:
